## AVIATION INVESTIGATION REPORT

A03O0171

### CONTROLLED FLIGHT INTO TERRAIN

BEECH 58TC BARON, N6058T

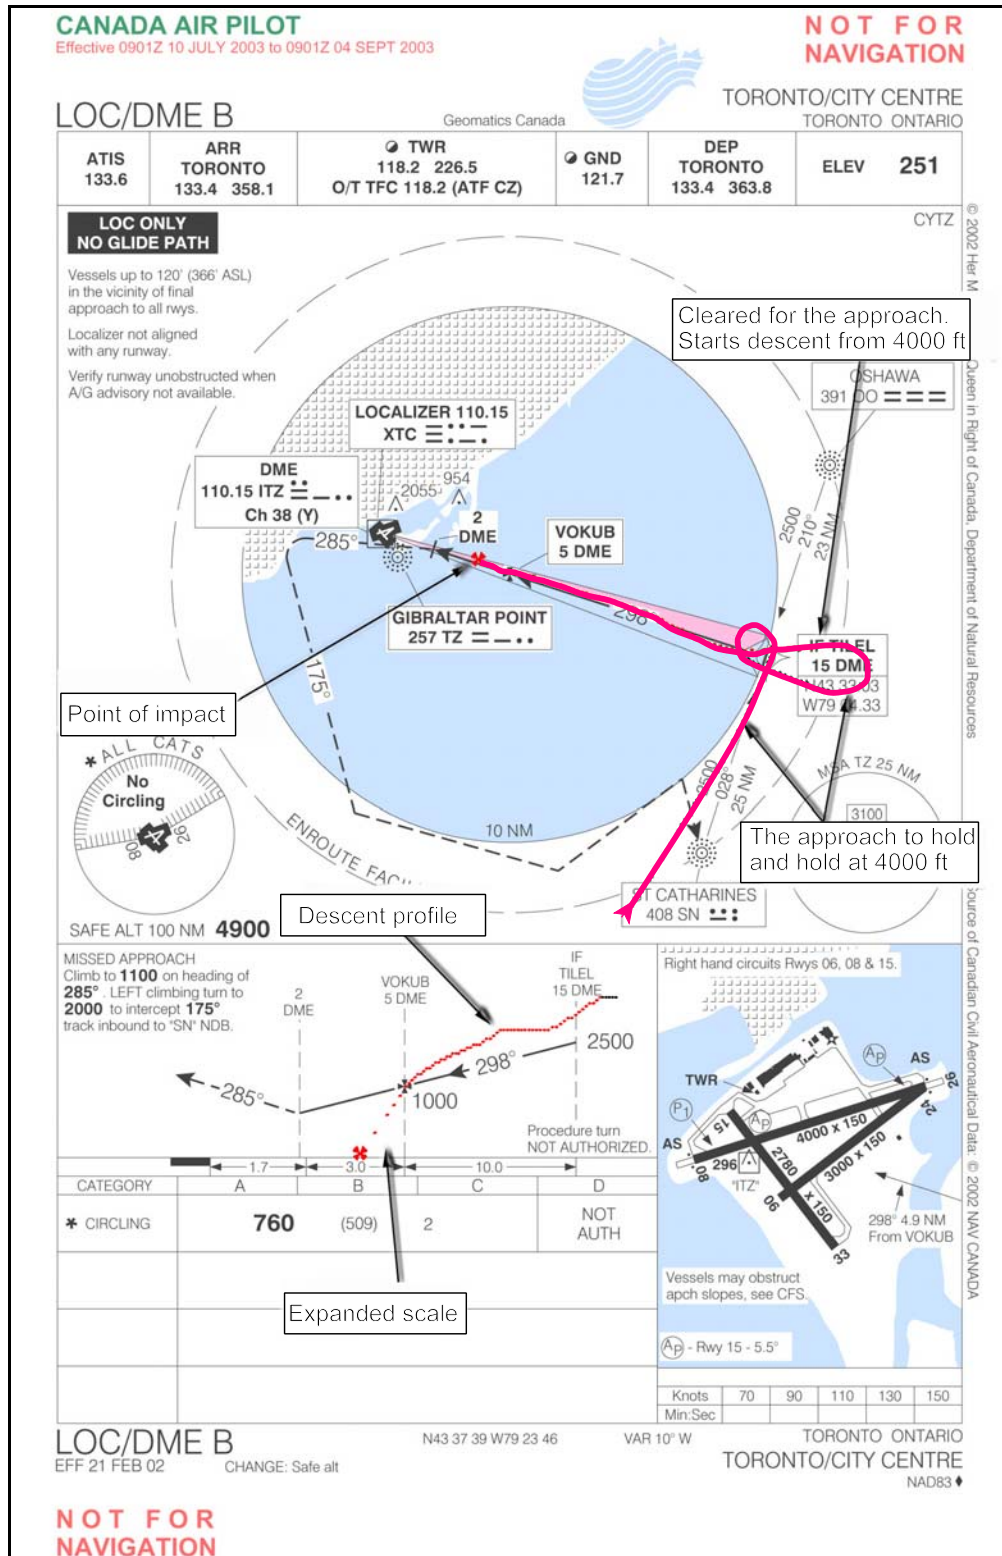
# Appendix A – Flight Path Information

Data was obtained from a radar located at Toronto/Lester B. Pearson International Airport (LBPIA), 14 miles northwest of the TCCA. Track and altitude derived from the radar data is presented in Appendix A. The aircraft maintained an altitude of 4000 feet asl and an airspeed of approximately 140 knots<sup>4</sup> while entering the hold. When cleared for the approach, the pilot began an immediate descent and airspeed increased to approximately 190 knots. The aircraft crossed TILEL, descending through approximately 3500 feet asl.

At 13.5 DME, the aircraft levelled at 2900 feet and the airspeed decreased to 150 knots. The aircraft resumed its descent at 11 DME, initially with a rate of descent of approximately 1000 feet per minute, then reducing to 600–700 feet per minute with an airspeed reduction to approximately 120 knots. At 6.5 DME, the rate of descent began to increase again and the airspeed increased to approximately 150 knots. According to radar, the aircraft passed the 5 DME fix at exactly 1000 feet. The last radar hit was at 500 feet asl, with a rate of descent of approximately 1200 feet per minute and an airspeed of 150 knots. The geographic position of impact was consistent with the radar data.

Two miles before the VOKUB 5 DME fix, the rate of descent and airspeed both began to increase. The increased rate of descent resulted in N6058T crossing the VOKUB 5 DME fix at exactly the published 1000-foot minimum altitude, descending at 1200 feet per minute, a significantly greater rate of descent than necessary to reach MDA by the 2 DME missed approach point. This rate of descent continued until impact.
